Our Ref: JKK8600

Date: 5 April 2019

VISUAL STRUCTURAL ENGINEERS INSPECTIONS BUCKLAND LODGE, NETHERFIELD, MILTON KEYNES, MK6 4JR

RPS DRAWINGS JKK8600_01_BUCKL and JKK8600_02_BUCKL

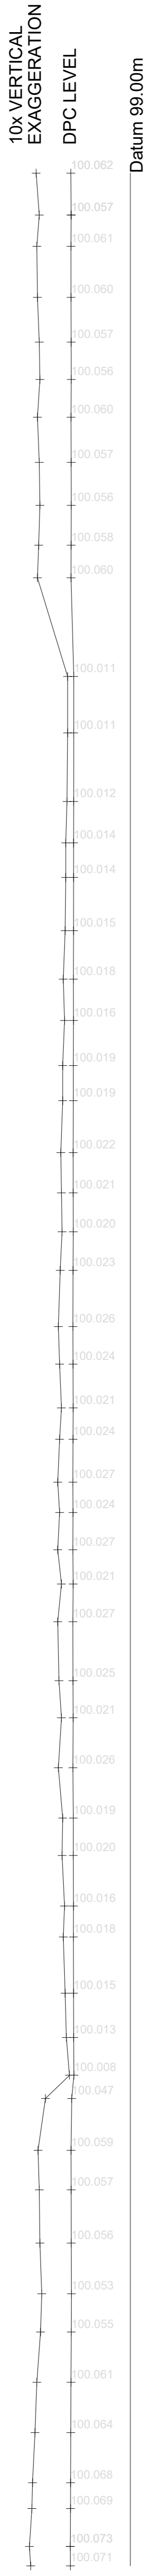
ELEVATION 1

The variation in DPC level to the external elevation along Farthing Grove, Elevation 1, shown in the RPS January 2019 survey appears to suggest a settlement or subsidence along this line. In 2005 along this boundary there was a line of Lime trees, which have now been removed. These Lime trees were noted in the contemporaneous RPS Arboricultural report as being as around 7 to 10 metres tall. The foundation along this elevation noted in the Listers soils investigation report as extending to around 1 metre below ground level. Thus based current NHBC Standards assuming the Lime trees were removed at the height noted, then an around 1.3 to 1.5metre deep foundation would be required. The level surveys carried out between 2007 to 2018 show a level recovery of around 5 to 15mm has occurred to points along this elevation. It is noted that in the Listers Trial pit Logs that the trial pit to the middle of this elevation shows the DPC level at Ground Level rather than at around 200mm above ground level at the ends of the elevation. From the visual inspection the level of cracking seen to this elevation is not consistent with the dipping in level that the DPC Level Survey appears to show.
